SUBSEA REPAIR OF NAB TOWER

James R Dale MEng BSc(Hons) CEng MICE
Manager, Underwater Engineering - Posford Duvivier Ltd¹

Andy Goddard, Managing Director - Andark Diving Ltd

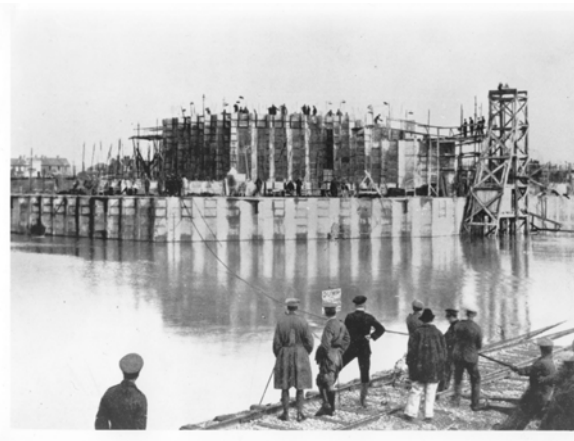
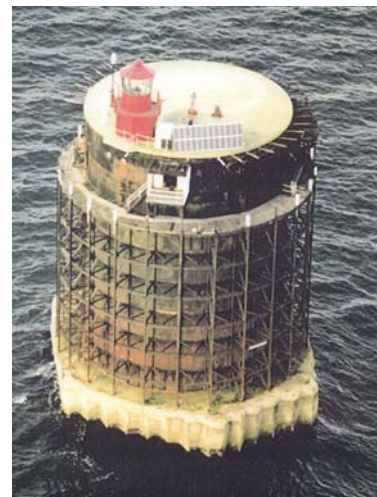
Nab Tower is the only remaining tower of fourteen intended to form a chain of anti-submarine defence forts across the English Channel during World War 1. They were designed as concrete cellular caissons supporting a steel structure. Construction commenced in 1918 (see Photo Below) but by the end of the war only two were anywhere near complete. One tower was completed and replaced the Nab Tower Light Vessel in 1920, marking Nab Rock, and the other was destroyed two years later. The present Nab Tower, situated 4 miles east of the Isle of Wight in the Solent and sitting in approximately 25m water at high spring tide, continues to serve as a navigation light tower (see Photo Below). The Trinity House Lighthouse Service has been responsible for the tower for a number of years.

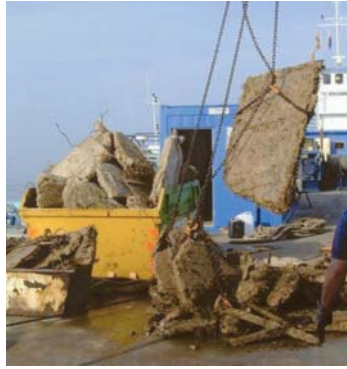
An initial check on the underwater situation was performed by Andark Diving and Posford Duvivier at an early stage in the contract. Having discussed the outcome of this overall condition survey, it was agreed by all parties to clear the debris (see Photo Below), test some concrete samples and run a full-scale grout bag test onshore. Interaction of ideas and discussion between all the parties was actively encouraged throughout the whole period in order to arrive at the most practical way forward.

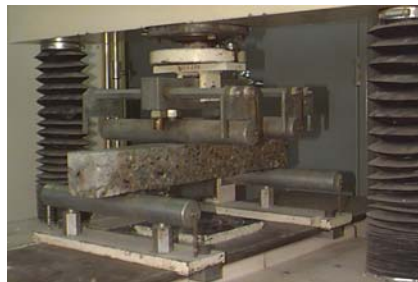
Some concrete cell wall samples were retrieved on the first dive for analysis in the University of Portsmouth materials testing laboratory (see Photo Below). The tests called for beam and cylinder strength tests together with general comments on the steel mesh and the concrete properties. To everyone's surprise the concrete turned out to be very strong, very compact and in very good condition. Compressive strengths varied from 35-64 N/mm² with associated densities of 2260-2370 kg/m³ (flint seabed aggregate) and tensile strengths were between 2.9-3.2 N/mm². The Expamet no. 21 mesh at 3.3mm in size was also in impressive condition, considering it was 83 years old and only had 15mm cover. There was no carbonation evident and the entire concrete sample was strongly alkaline. The results of the tests were used in the design of the cell loading capability and the ladder fixings. The cell slab was calculated to be capable of only taking a 1.4m height of mixed debris with the grout bag on top.

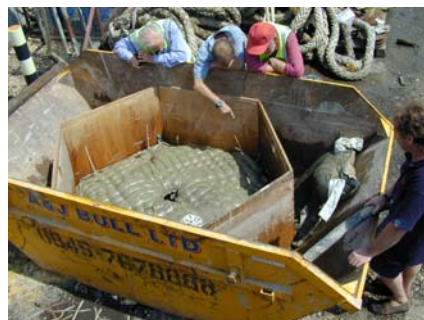
Andark Diving put one day aside within the contract for an essential onshore grout mattress site test (see Photo Below). This proved to be very useful to iron out procedural matters and make adjustments to the design of the grout mattress, the concrete mix and the bag fixings to the cell walls before the offshore work commenced on Stage 2. The grout mix finally agreed after the test was a 1:2 cement/sand mix with a w/c ratio of 0.5 and flow cone durations of 27-33 seconds to ASTM C939-97 Flow Cone Method.

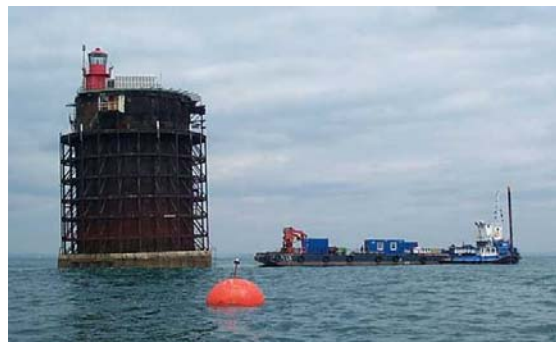
One of the most important items of the project to monitor was the weather. Constant regard to the forecast was essential at this very exposed site, which was not diveable past wind Force 4. The plan for intermittent offshore diving made it even more relevant, particularly when the “Wilcarry” (the 42m x 10m, 180 tonne load capacity, 15 tonne crane lift) barge of Williams Shipping, was moored in Southampton when not in use and required notice to be towed offshore by tug (see Photo Below).

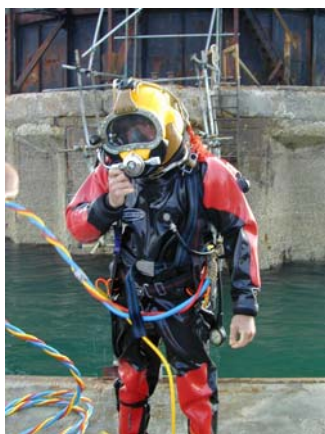
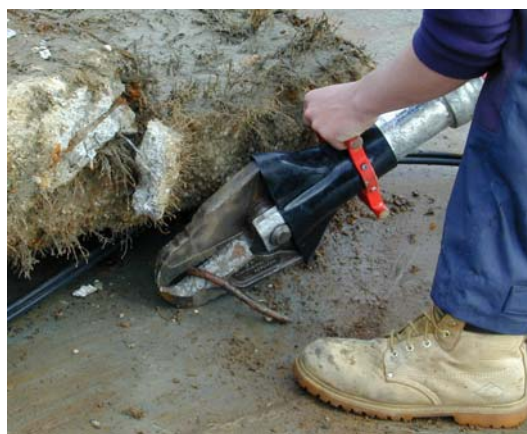
The clearance operation commenced in April 2001 with the diving team concentrating on making the site underwater safe to work around and inside the cells. The six man dive team used Kirby Morgan dive helmets and band masks with surface supplied equipment (see Photo Below). Diving was done on a ‘no-decompression’ basis to the US Navy 1995 diving tables with normally only a single working diver at high and low slack water. A considerable entanglement of steel bars and concrete slabs faced the divers at different levels. A rope grid system was set out for use as a guide to locating the cells, which were individually marked with numbered disks. The use of the Lukas hydraulic cutter, similar to the ones used by fire and rescue services, and pneumatic breaker tools helped to speed up the removal of debris (see Photo Below).
